Manhole Inspection Summary

Manhole # S43E__056MH

Insp Date: **6/11/08 10:14 AM**

Location Address: **1645 e baltimore st**

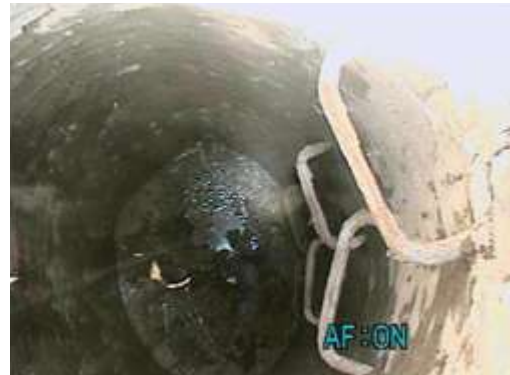
Top View

top view & steps

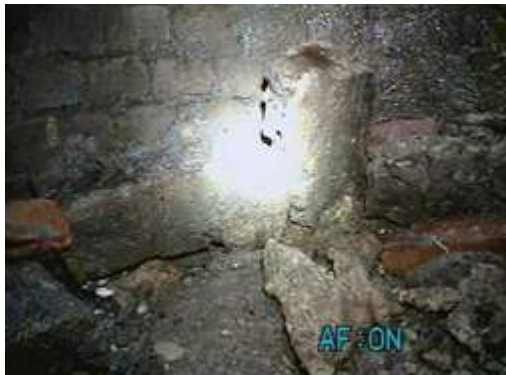
Defect 2

Condition: ☐ Sound ☐ Cracked ☐ Root Intrusion ☐ Deteriorated ☐ Leaks ☒ **Debris**

channel debris

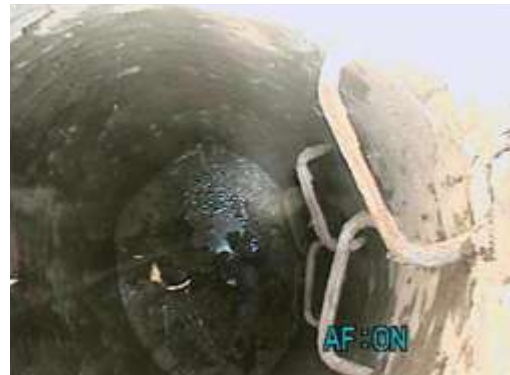
Defect 4

Count: **6** Missing: **0** ☒ **Corroded**

corroded steps

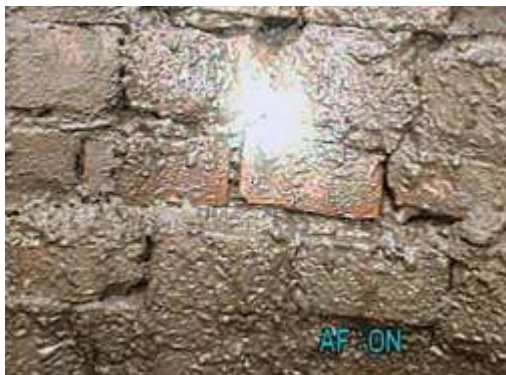
Defect 1

Condition: ☐ Sound ☒ **Cracked** ☐ Root Intrusion ☒ **Loose Brick** ☐ Deteriorated

Infiltration: ☐ None ☐ Joint ☒ **Cracks** ☐ Mortar ☐ Roots ☐ Wall

cobel cracked & deteriorated with infiltration from cracks

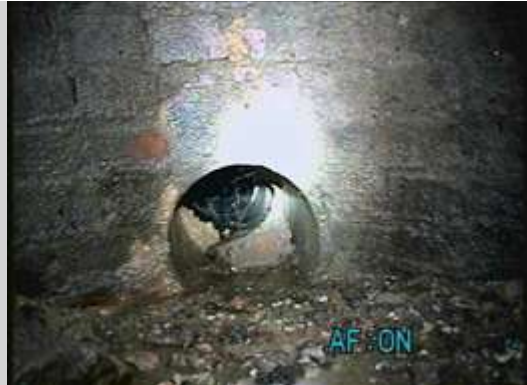
12 O'Clock Outflow

8 in. Circular Gravity Sewer
Pipe Out @ 12 O'Clock

Deposits: ☐ None ☐ Mud ☐ Sludge ☒ **Debris** ☐ Grease

Silt Depth: **0** (in.) Deposits Extent: **Medium**
